Fatality Investigation Report

OR 2015-12-1

Construction worker died after falling 20-25 feet from a pump-jack scaffold

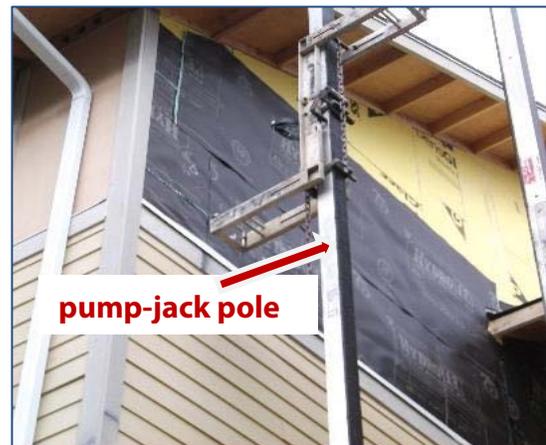
Figure 1 (above). Breezeway, pump jack pole.
Figure 2 (below). Breezeway, 3rd floor stair landing with temporary railing.

stair landings, and related structures in the breezeway had hindered the ability to set up a standard scaffold system. This resulted in an incomplete scaffold system set-up around the stairs, with not all of the standard scaffold system components used. Instead they used only one pump-jack pole, supporting one end of the scaffold platform, and used the stair landing to support the other end of the platform. To raise the platform above stair landing height, an 8-foot step ladder was placed on the landing to support that end of the platform and the pump-jack pole was raised on the other side. No fall protection was used during siding work in this breezeway.

- In this case, given that the stairs impeded the ability to install a complete pump-jack scaffold system, an alternative method for more safely accessing the height should have been determined. For example, an aerial lift could have been used to access heights in the breezeway that could not be reached using standard pump-jack scaffolding.

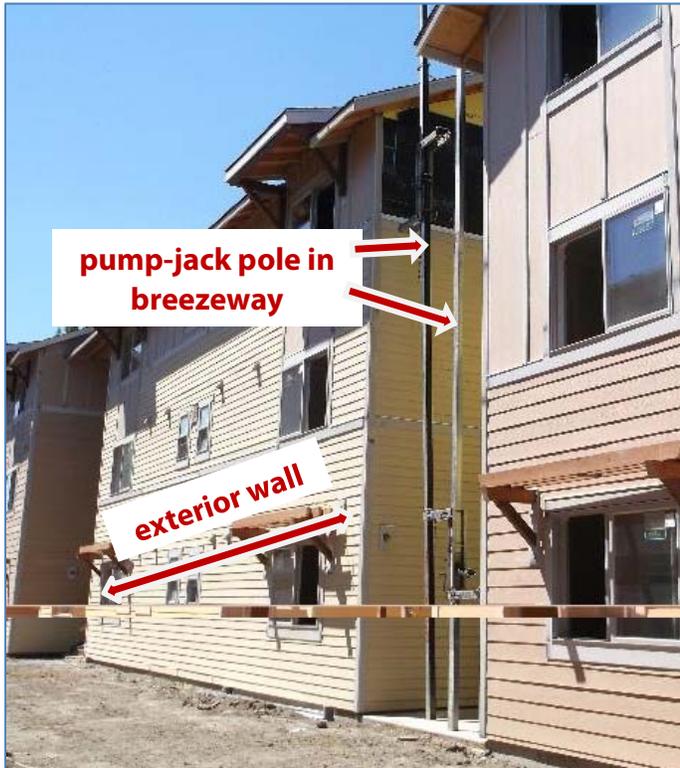
Figure 3. Exterior wall and breezeway.

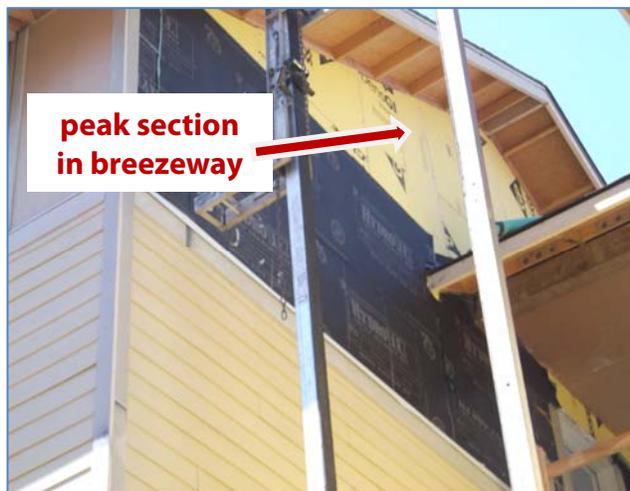
According to OR-OSHA observations and information obtained through interviews, building wrap and siding had been installed on two lower levels. The crew recalled seeing that the platform was level as the work progressed to the third level. To complete the top section siding required gaining additional height to reach the triangle shaped roof peak area above the third level landing (see Figure 4). It was assumed that to do this, the victim had placed a 6-foot step ladder on top of the scaffold platform. The victim was working alone at the time of the incident, and was not using fall protection. The three siding crew members who been assisting earlier in the day had been asked by a jobsite superintendent to perform a task on another building. Thus, they were not in the immediate vicinity at the time of the incident, nor were any other workers in the immediate vicinity. Therefore, no witnesses directly observed the specific configuration of the scaffold platform or the inferred use of the second step ladder on the platform, nor did anyone see what the victim was doing just prior to falling, or what may have triggered the fall.

Figure 4. Peak section of breezeway wall.

Scaffolds and ladders that are not properly installed or secured can tilt or sway and become unstable. In this case, two contributing factors may have affected the stability of the work platform and its ability to withstand side forces. The scaffold platform was not secured on the stair landing and was supported by a step ladder. It is possible that as a result the platform tilted or swayed, causing the victim to lose his balance, or he may have fallen because he lost his footing using the second step ladder while attempting to reach the peak section.

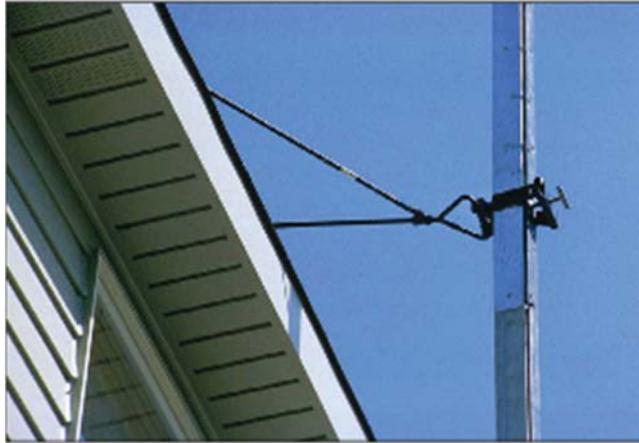
Figure 5. Example of scaffold pole properly secured to building (from OR-OSHA publication, "Supported Scaffolds").

- Securing poles to the structure with rigid triangular bracing (see example in Figure 5);
 - Safe access to scaffolds and scaffold platforms; and
 - Use of fall protection, such as personal fall arrest systems or guardrails, when working at heights more than 10 feet above a lower level.
