INCIDENT FACTS

71-171-2018

Warehouse Worker Crushed by Forks of Laser Guided Vehicle

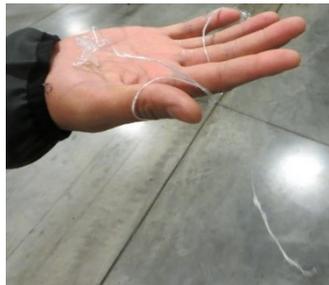
Example of a plastic “stringer” torn from pallet wrapping that often obstructed LGV sensors.

Investigators believe that the victim attempted to remove a piece of plastic from under the elevated forks of the LGV without first initiating an emergency stop. Long strips of plastic wrap often tore off of pallets during loading and unloading and stuck to the forks of the LGVs. If the plastic entered the safety detection field of the LGV, it would be recognized as an obstacle. Other employees said that these plastic “stringers” frequently triggered LGV alarms. The victim was likely bending or kneeling under the forks outside of the safety sensor field to reach the plastic stringer. Because the LGV was not in emergency stop mode, the system reset when the obstacle was removed, bringing the elevated forks down, crushing him against the wheel cover of the vehicle.

- Incorporate manufacturer safety requirements into written company safety procedures for automated guided industrial vehicles.
- Train workers about the specific hazards and safety requirements associated with automated guided industrial vehicles, like LGVs. Emphasize that workers are expected to follow required safety procedures every time, and ensure compliance through periodic refresher training and spot checks.

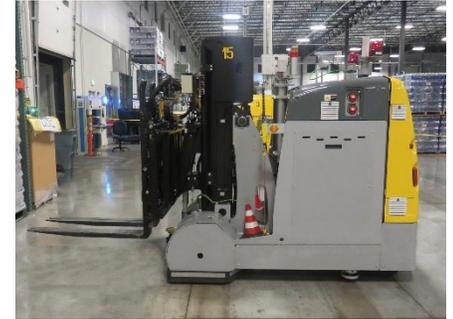
There were warning signs affixed to the vehicle indicating that workers should avoid standing beneath the elevated forks.

Photo of LGV involved in the incident.

- Employers must protect workers around PITs (powered industrial trucks), and not allow them under the elevated part of any PIT, whether it is loaded or empty. See [WAC 296-863-4005\(2\)\(a\)](#).
