Warehouse Worker Crushed by Forks of Laser Guided Vehicle

REPORT #: 71-171-2018s

REPORT DATE: 5/10/2018

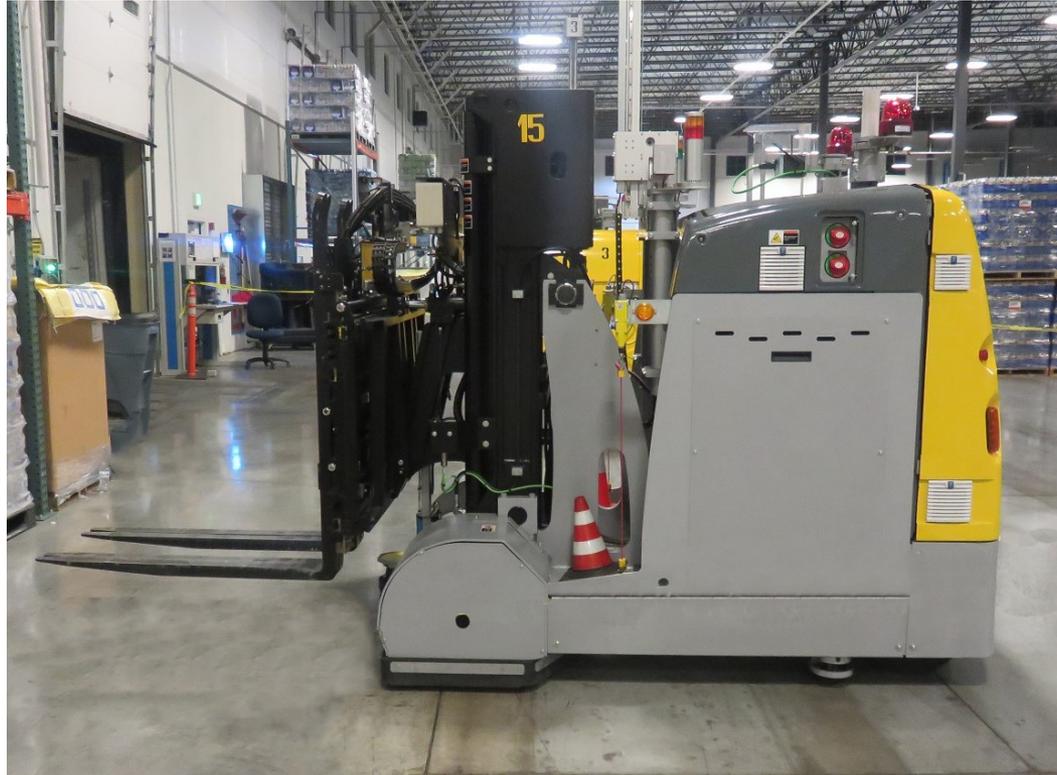
The victim was likely bending or kneeling under the forks outside of the safety sensor field to reach the plastic stringer. Because the LGV was not in emergency stop mode, the system reset when the obstacle was removed, bringing the elevated forks down, crushing him against the wheel cover of the vehicle.

Photo of the automatic laser guided vehicle (LGV) involved in the incident.

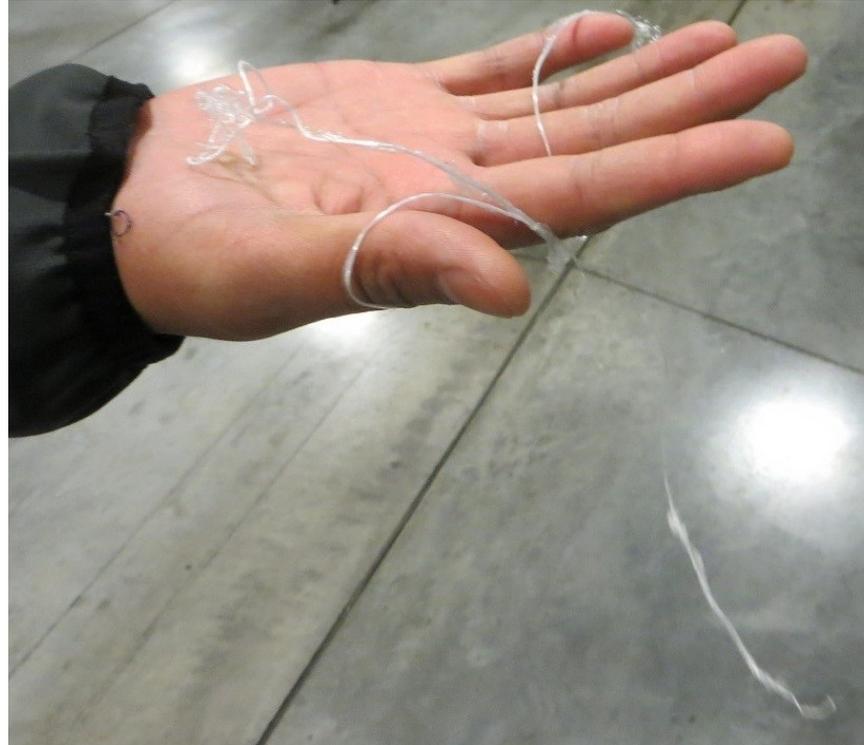
Investigators believe that the victim attempted to remove a piece of plastic from under the elevated forks of the LGV without first initiating an emergency stop. Long strips of plastic wrap often tore off of pallets during loading and unloading and stuck to the forks of the LGVs. If the plastic entered the safety detection field of the LGV, it would be recognized as an obstacle. Other employees said that these plastic “stringers” frequently triggered LGV alarms.

Example of a plastic “stringer” that would often tear off of the wrapping around the pallets of water bottles during loading and unloading and become caught on LGV forks. Stringers hanging from the forks that entered an LGV’s safety detection field would trigger an alarm and pause automatic movement.

After the incident, the company trained employees to initiate an emergency stop before clearing an obstacle from an LGV's path, and to use a long-handled snipping tool to remove plastic stringers instead of reaching or bending under the forks of the LGV.

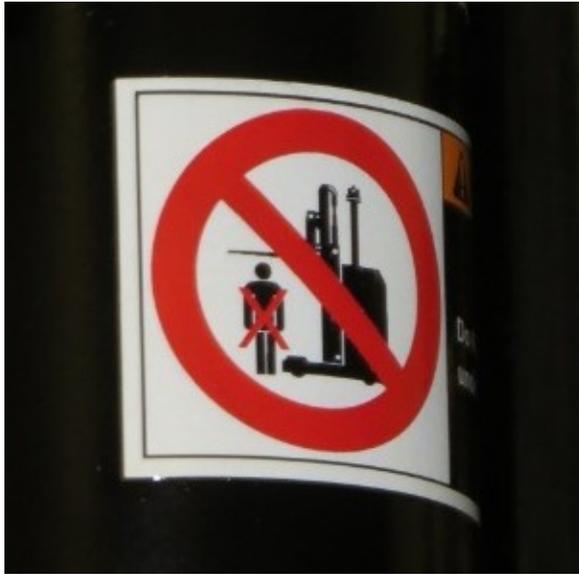
There were warning signs affixed to the vehicle indicating that workers should avoid standing beneath the elevated forks.

Sticker on the LGV indicating that working underneath elevated forks was prohibited.

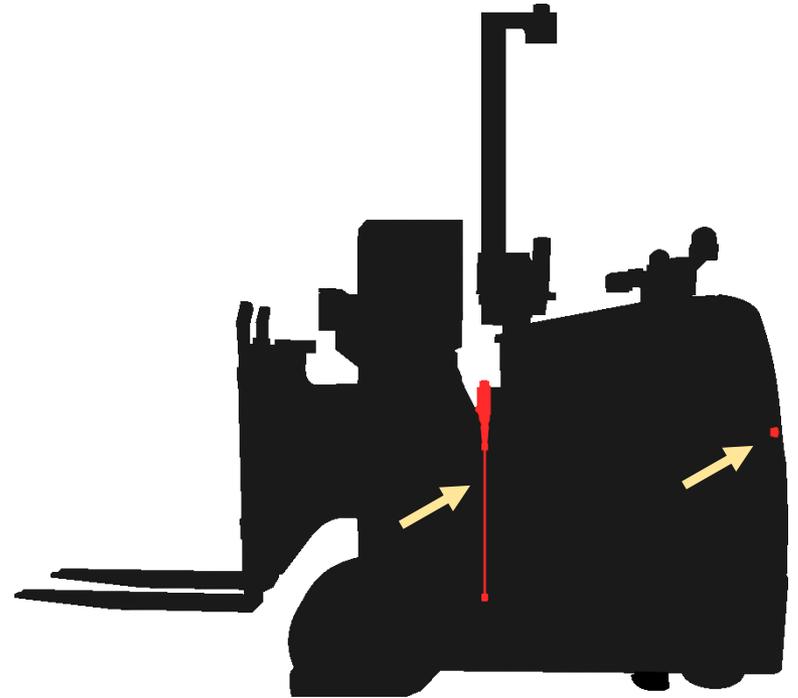
The manufacturer's manual required workers to initiate an emergency stop before removing an obstacle detected by the LGV. An LGV would then have to be manually reset before restarting its task. Without initiating an emergency stop, the LGVs would resume automatic function immediately after an obstruction was removed.

Diagram indicating the location of the emergency stop button and rope pull. An identical set was present on the other side of the LGV.
