PRODUCT SAFETY NOTICE

LADDER SAFETY SYSTEMS USING 3/8 INCH 7X19 STRAND GALVANIZED CABLE

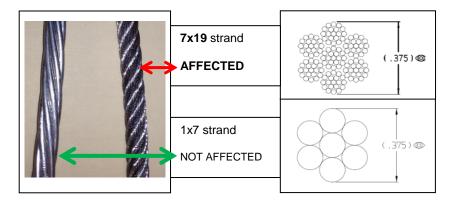
This Notice concerns the DBI-SALA Lad-Saf™ Flexible Cable Ladder Safety System, also known as a 'Safety Climb System.' Capital Safety has received a limited number of reports of **7x19** strand carrier cable slippage from the carrier clamp in the top bracket of these ladder safety systems. Although this top bracket design has been used in the market for more than 40 years without incident, the reported slippage raises the potential for injury to users of affected systems.

A top bracket assembly is depicted below, with diagrams and photos of **7x19** strand cable (affected) and 1x7 strand cable (not affected).

Capital Safety recommends that users: (1) inspect their systems prior to next use to determine whether 3/8 inch 7x19 strand cable is used and, if so, (2) determine whether the top bracket assemblies were purchased within the above date range.

If an affected Lad-Saf system or Safety Climb System is found, do not use the system until you have contacted Capital Safety Customer Service at 1-800-328-6146 (ext. 2012), or email us at csg.lss.inquiries@capitalsafety.com. We will answer inquiries and provide guidance on how to proceed.
