OREGON FATALITY ASSESSMENT AND CONTROL EVALUATION (OR-FACE)

Fatality Investigation Report

OR 2016-16-1

Construction worker killed when trench collapsed

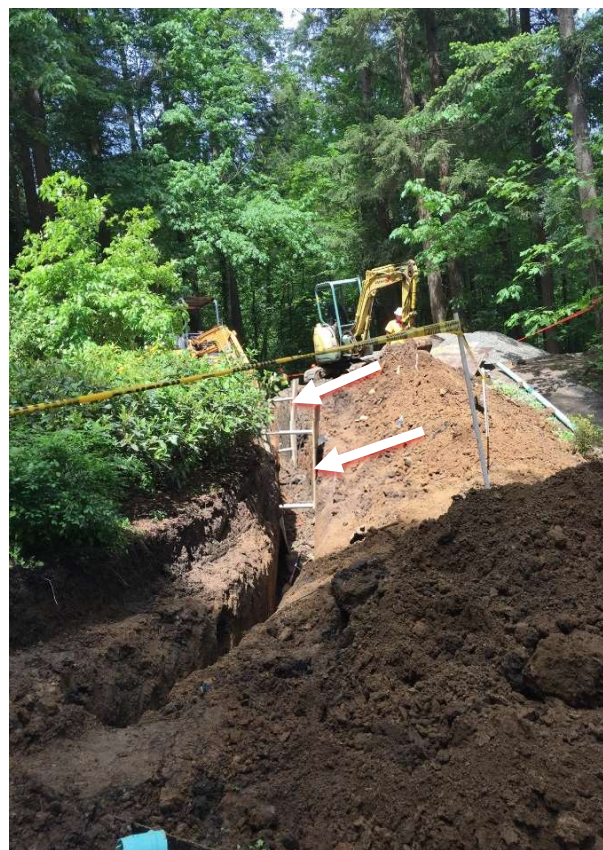
On May 5, 2016, a 29-year-old construction worker employed by a small excavation contractor was killed when the trench he was working in collapsed and buried him in approximately 6 feet of dirt. The worker was part of a crew installing a sewer pipe at a residential property. The trench was 10 feet deep and approximately 3 feet wide in the area where the collapse occurred. The collapse occurred in an unprotected area of the trench, between two pieces of shoring that were spaced 15 feet apart (see Figure 1).

Figure 1. View from front of house: area of incident showing placement of shoring; collapse occurred in between the two pieces of shoring spaced 15 feet apart (indicated by arrows)

The trench collapse occurred when decedent was working in an unprotected area of the trench between two pieces of shoring that were spaced 15 feet apart. The specific task being performed by the decedent at the time of the incident is uncertain. It was reported that he may have been checking the grading of the new sewer line. Other evidence suggests he may have been hand digging a high spot of soil or preparing to put in a pipe connector.

- Employers who have employees working in trenches that are 5 feet deep or deeper must select and install appropriate protection systems for the conditions present to protect workers from cave-ins. For trenches less than 5 feet deep, examination by a competent person for potential cave-in indicators is required.

- Trench protective systems may include shoring, sloping, and/or shielding. When shoring is selected as the appropriate protection system, the competent person must implement proper horizontal and vertical spacing, which includes placing the shoring the proper distance apart (in this case, a maximum horizontal spacing of 6 feet for Type C soils). However, the shoring in this case was spaced 15 feet apart (too wide to adequately support the trench wall) and it failed to protect the worker in the trench.

- In this case the competent person reported defaulting to a presumed worst-case soil type (Type C, the least stable type of soil). However, performing a visual and manual test and consulting the tabulated data or the OSHA tables and charts would have provided a better understanding of soil and site conditions including any surface encumbrances and other potential hazards to be mitigated prior to starting work. Making assumptions about site conditions devalues the need for a knowledgeable competent person and increases risk of injury. Further, the maximum horizontal spacing for Type C soil is no more than 6 feet (along with a waler system). The shoring in this trench was spaced 15 feet apart and omitted a waler system.

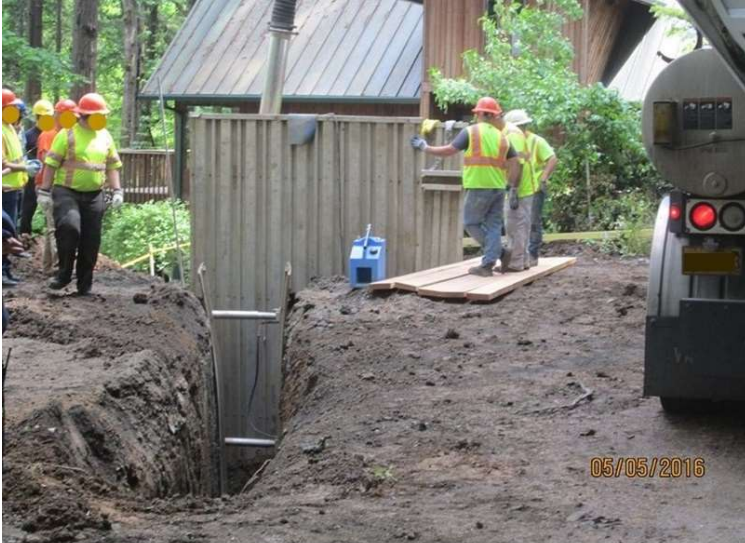
When the trench collapsed, co-workers called 911 and attempted unsuccessfully to locate and dig the worker out. When emergency responders arrived, their first task before commencing rescue and recovery efforts was to shore up the trench to prevent risk of additional collapse and injuries (see Figure 2). Emergency responders spent several hours recovering the worker's body.

Figure 2. Emergency responders preparing to install a trench box before starting rescue and recovery work, to prevent risk of additional collapse and injuries

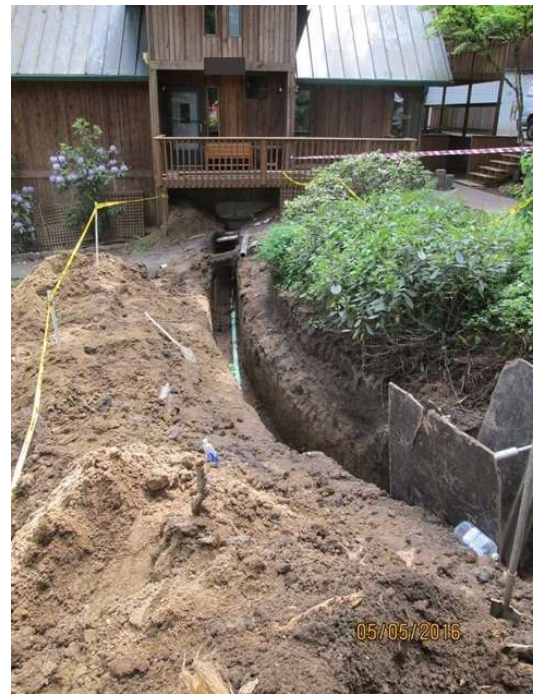
On the day of the incident, the decedent and a co-worker were working in the trench in front of the house (see Figure 3). As shown in the photos, the property was heavily wooded, and soil conditions around the property varied (see Figures 1 through 4). Two pieces of aluminum hydraulic shoring were installed in the trench. The foreman had installed the shoring. Evidence suggests that the foreman was less knowledgeable and experienced than the employer/owner (competent person) in installation of shoring systems. It was also reported that the competent person did not inspect the shoring before work started or during the work shift, as required.

Figure 3. View of trench work area in front of house

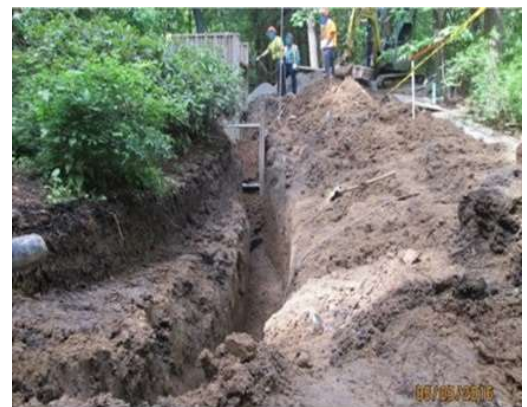
Figure 4. View from house showing trench work area and general soil conditions

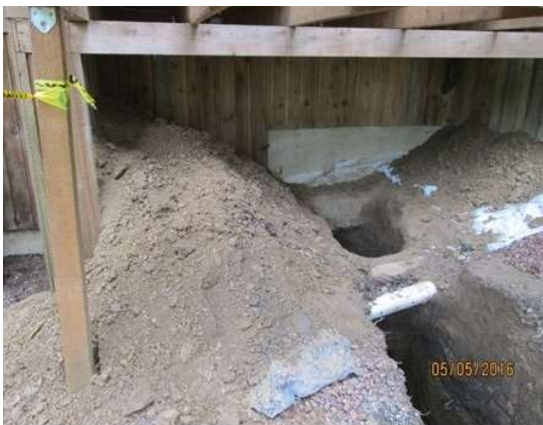
Figure 5. View of work area under deck of house where spoils had been placed at the open edge of the trench

Another hazard identified was the placement of excavated soil (spoils) on the edge of the trench that was located underneath the deck at the front of the house (see Figure 5). The spoils pile in this location was reported to be approximately 2 to 3 feet high. Spoils piles should be placed at least 2 feet from the edge to prevent creating a surcharge (meaning that it places extra pressure on the trench wall and affects trench stability). Alternatively, retaining devices may be used to prevent material from falling into trench.

In addition, while not specifically related to the collapse, the owner was reported to have said they would have been unable to install any form of shoring in the area underneath the deck (shown in Figure 5). Investigation findings suggest that while this may be the case, the contractor could have used alternative, safer practices to reduce cave-in risk in this situation. Examples could include use of boring equipment that could eliminate the need for a worker to enter a hole that cannot be protected with shoring or other protective systems.

- It also is important to consider any obstructions that might hamper the use of standard protective equipment, and to take the time to determine ways to abate any hazards and/or identify alternative safe measures for performing the work. Do not take shortcuts or ignore these conditions. For example, the property in this case was heavily wooded. Per discussion with an OR-OSHA investigator, a large tree root ball in one area of the trench obstructed an area where shoring would have been placed. One possible alternative for an obstructed area could be to use a trench box or shield instead of shoring.

Recommendation #5: Keep excavated soil (spoils) and other materials and tools at least 2 feet from the edge of the trench.

- Placing a load too close to the edge of the trench imposes a surcharge. This means that the spoils increase lateral pressure on the affected zone of the trench, thereby impacting the stability of the trench.
- In this case, the spoils from under the deck in front of the house were placed at the edge of the trench in that location.
