# Fall Hazards in Commercial Construction: Lessons Learned from a Unique Opportunity

# A unique opportunity to Study Fall Hazards in Commercial Construction

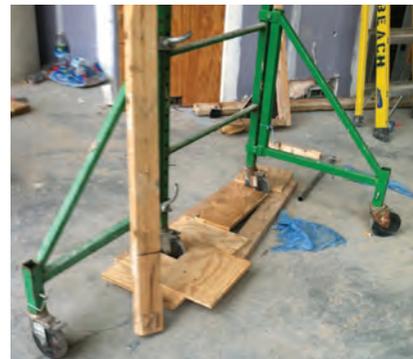
Figure 3: Improperly secured base on mobile scaffolding

were instances where workers used mobile scaffolds without first locking the wheels to prevent the equipment from moving. Although observed less often, another issue resulting in the increased risk of falling was the lack of proper railings on a mobile scaffold. According to observer notes, carpenters were the most common users of mobile scaffolds during the skin and interior rough-in phases.

The main worksite issues observed by GW researchers during the project were with mobile scaffolding. Many of the workers using this scaffolding were puzzled when asked by the construction supervisor what was wrong with their set-ups. These problems were almost always due to the wheels being unlocked while in use.
