**Preventing
Falls
from
Ladders
in
Construction**

2009 Study

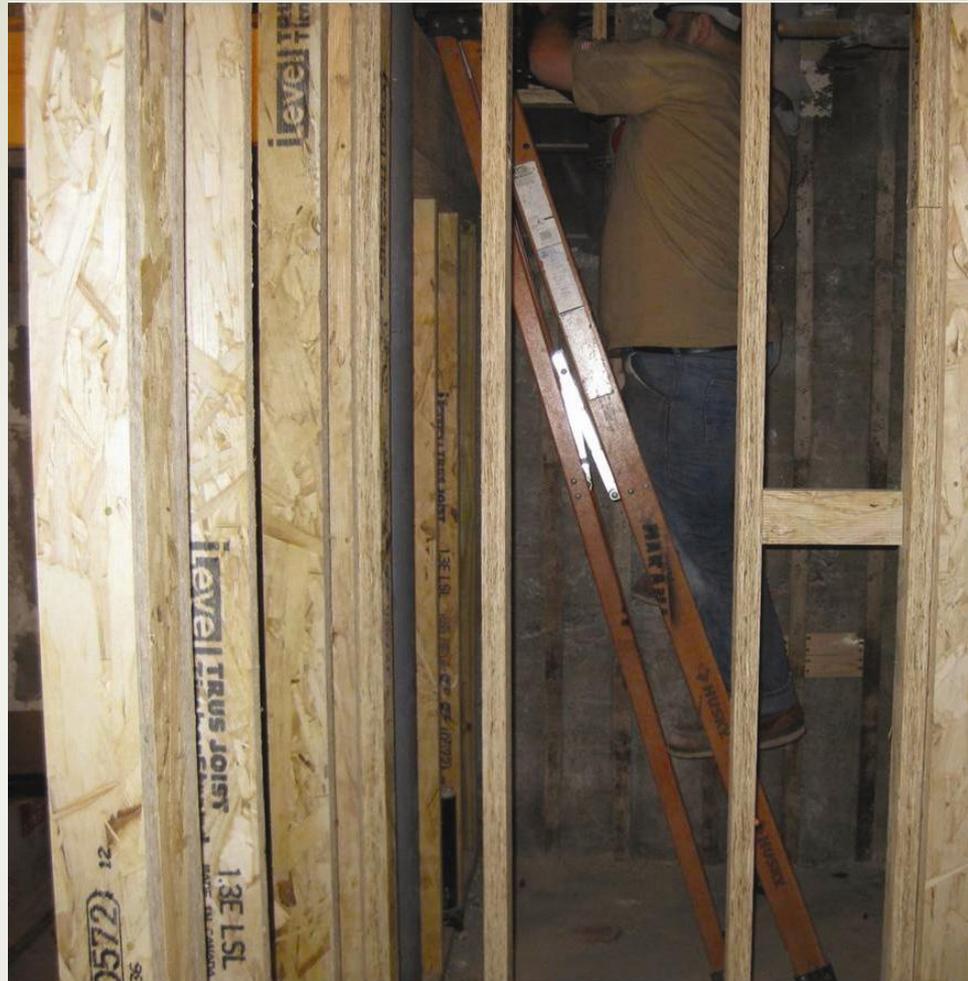
Ladder is placed incorrectly. Ladder should be extended out with its spreaders locked. If the work area is too small, an alternative should be used.

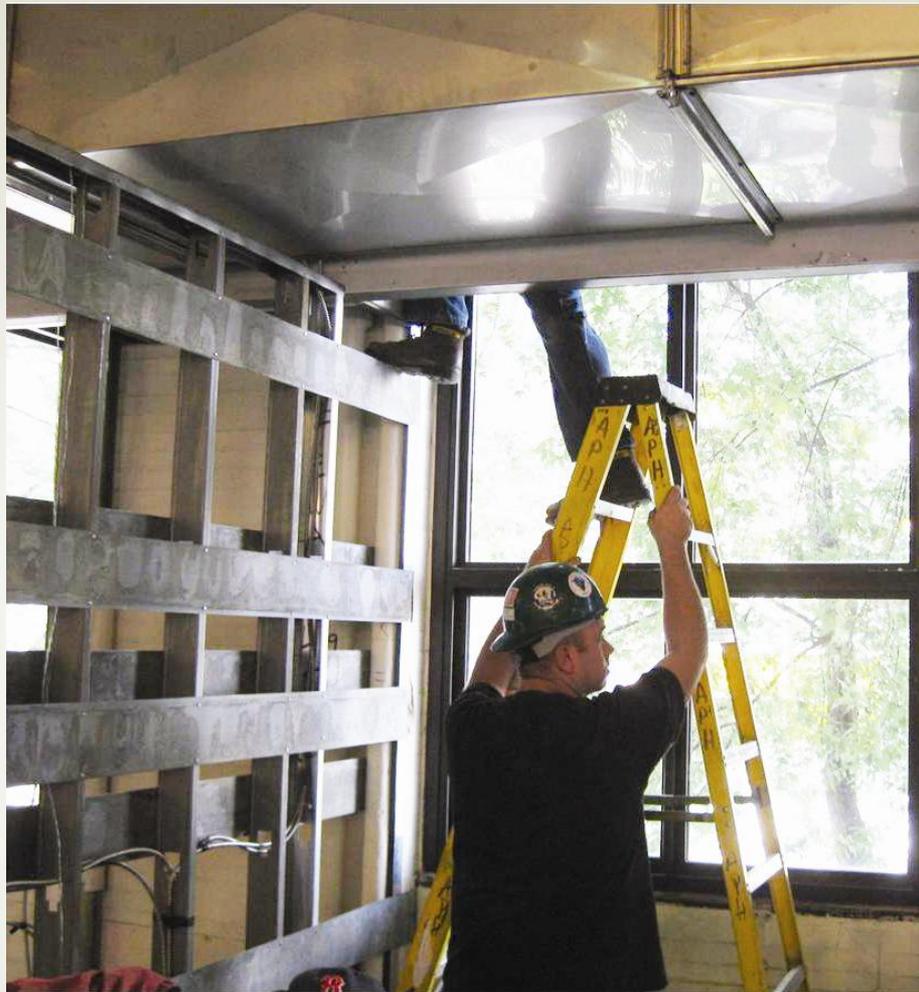
Unsafe posture. Worker should be facing the ladder and on a lower rung. A taller ladder facing the opposite direction may be necessary.

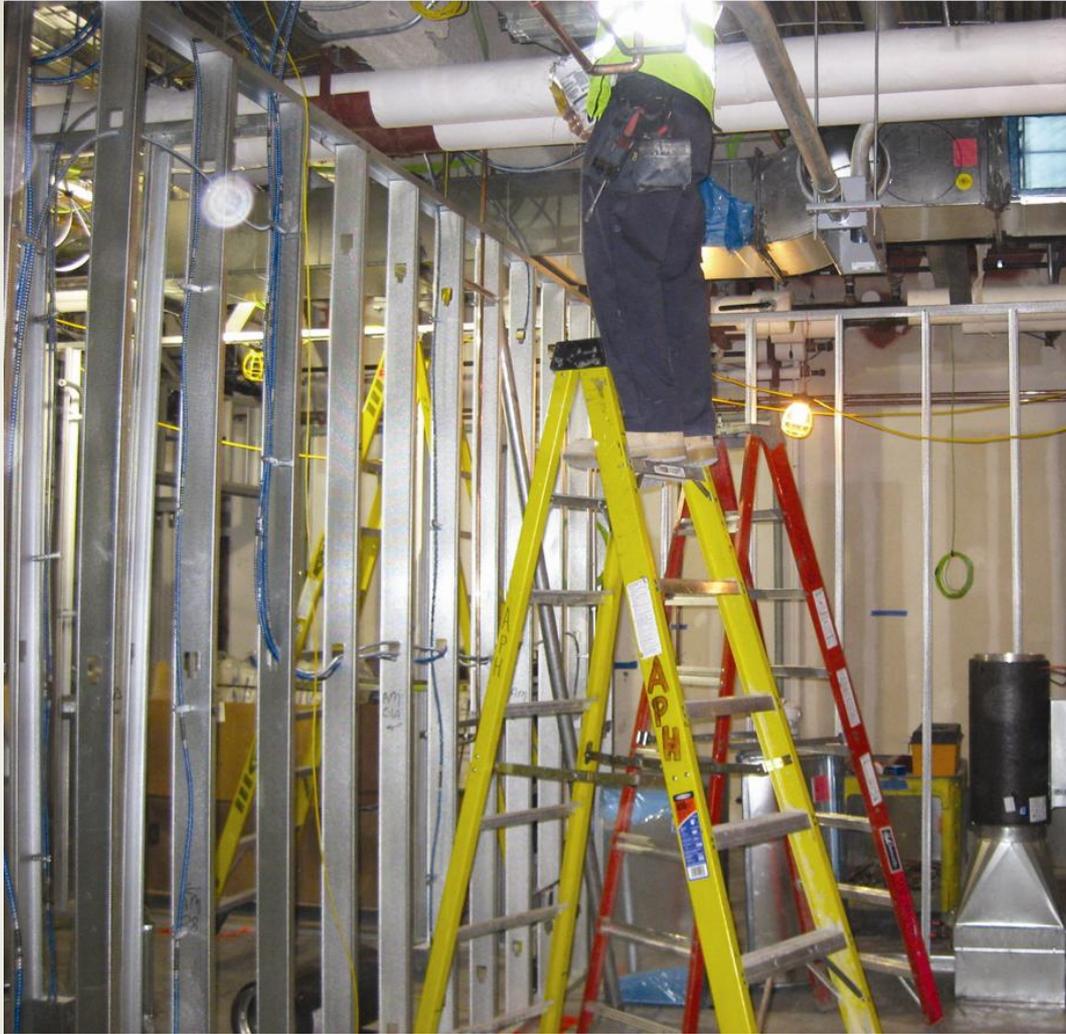
Unsafe posture. Worker should be on a lower rung; a taller ladder is needed.

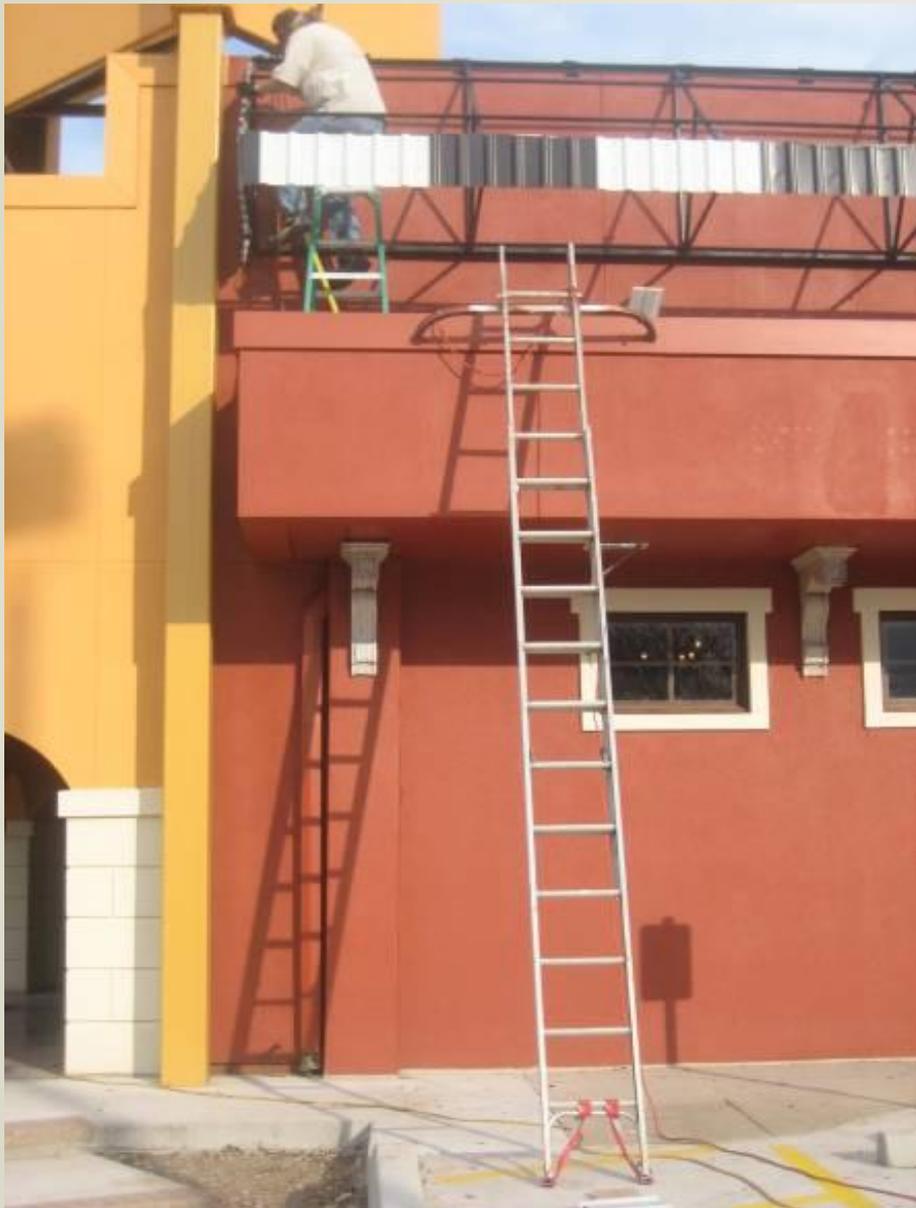
Extension ladder should extend past the roof by at least three feet. Worker is in an unsafe posture. He should be standing on a rung and should be wearing fall protection.

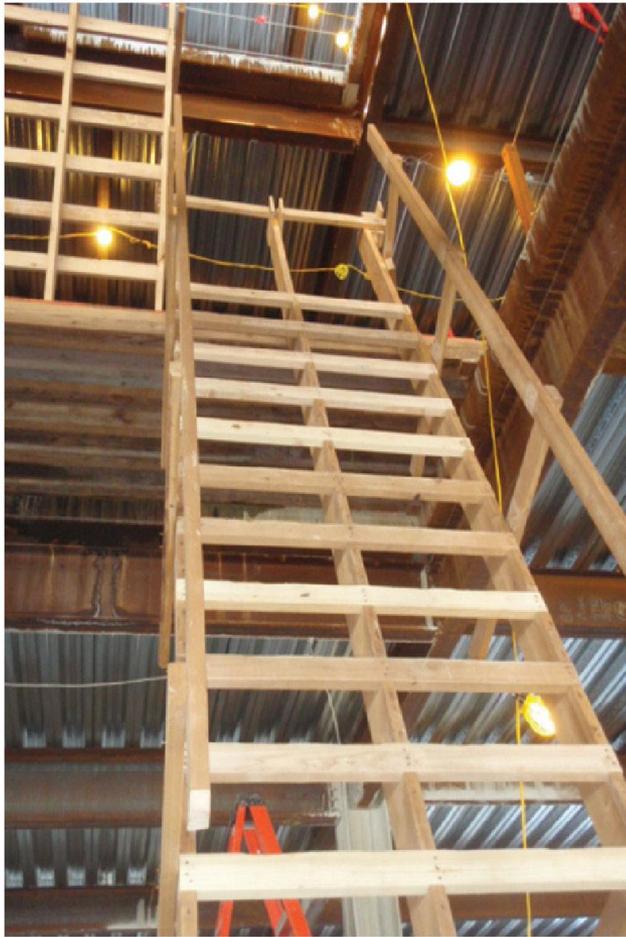
Adjusts for 14' to 17' landings

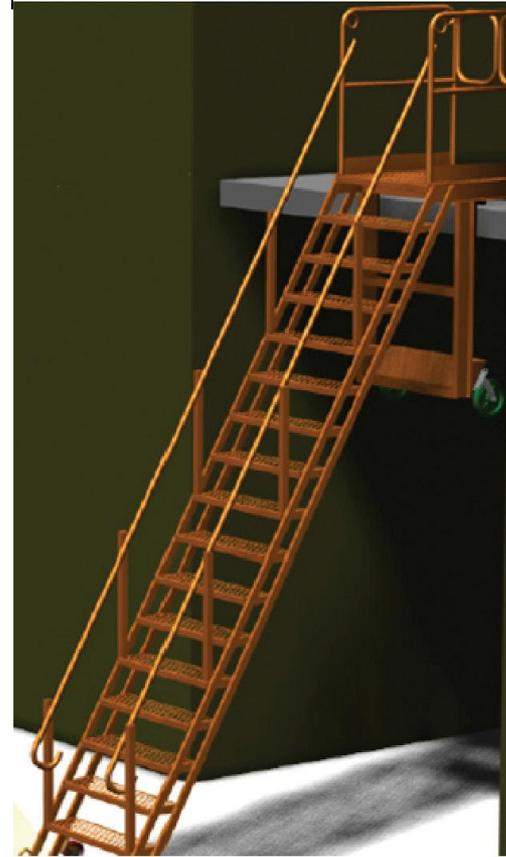
The portable stairs on the right are able to be reused on several projects while allowing the workers a safer angle for ascent and descent compared to the gang-ladder on the left.

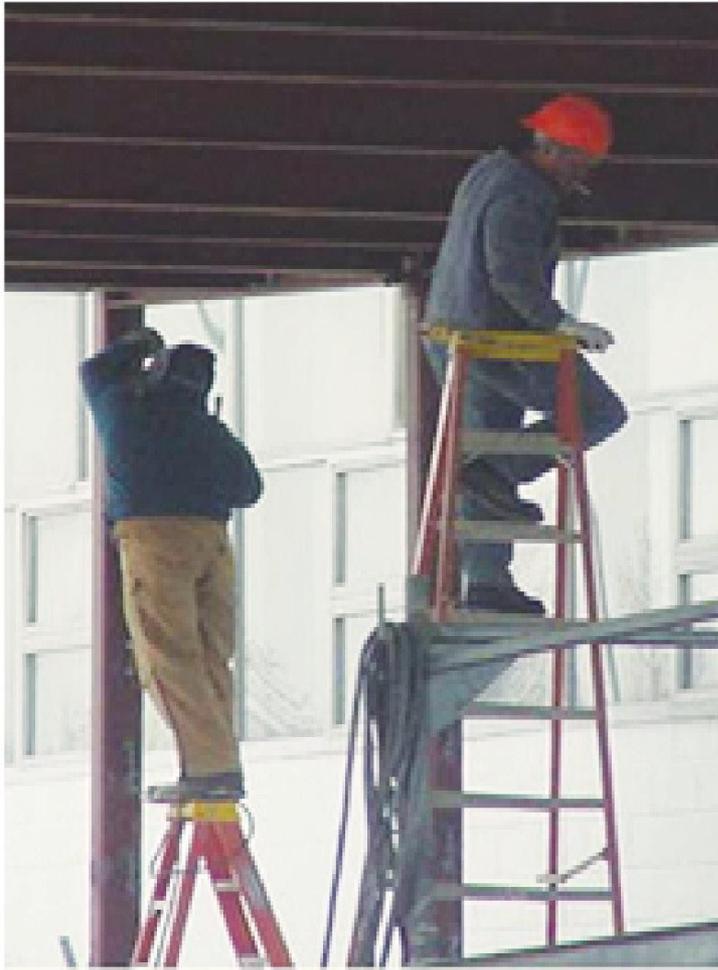
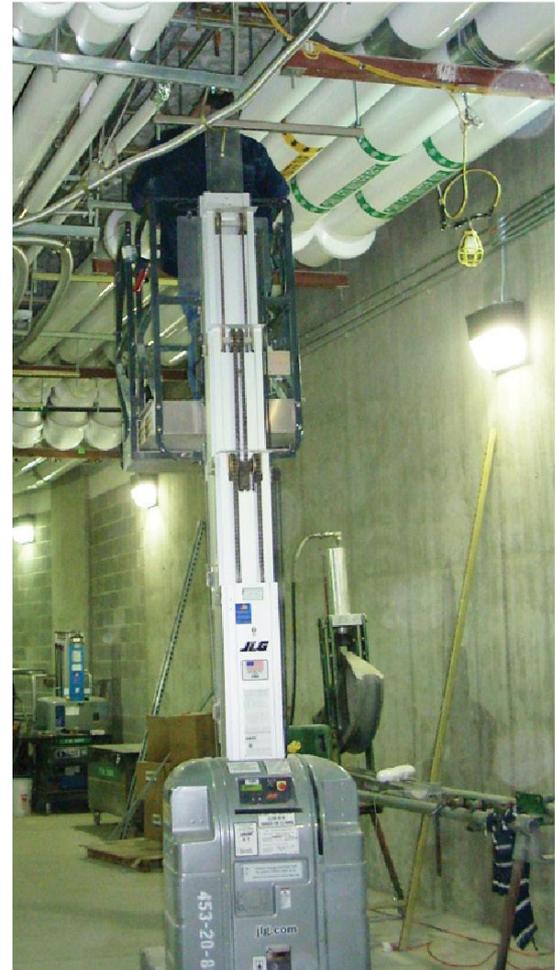
The lift on the right allows a worker to reach heights while providing a safe working platform and small footprint in the hallway compared to the very tall step ladders on the left that are still not tall enough for the workers to safely reach their job tasks.
