Warehouse Worker Crushed by Forks of Laser Guided Vehicle

REPORT #: 71-171-2018s

REPORT DATE: 5/10/2018

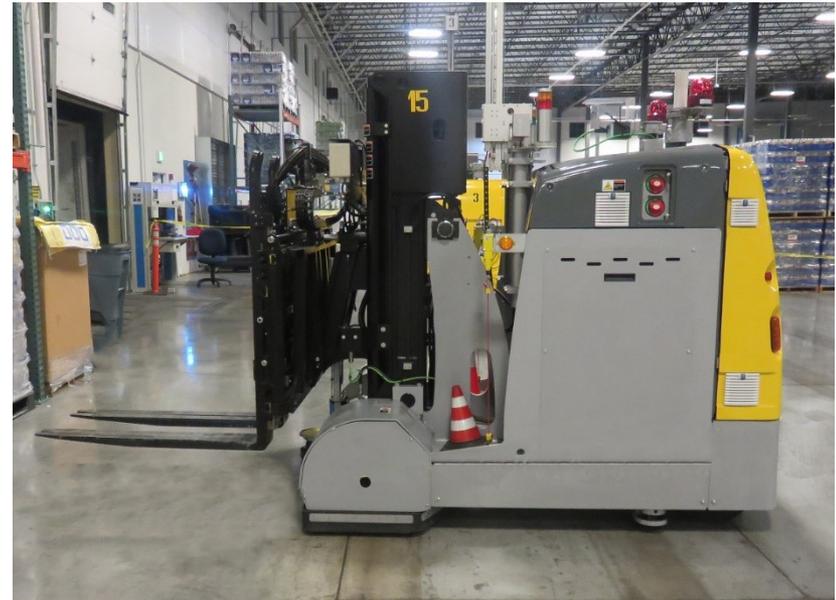
In December 2015, a 45-year-old warehouse dock coordinator at a water bottling company died after he was crushed when the elevated forks of an automatic laser guided vehicle came down on him.

Investigators believe that the victim attempted to remove a piece of plastic from under the elevated forks of the LGV without first initiating an emergency stop. Long strips of plastic wrap often tore off of pallets during loading and unloading and stuck to the forks of the LGVs. If the plastic entered the safety detection field of the LGV, it would be recognized as an obstacle. Other employees said that these plastic “stringers” frequently triggered LGV alarms.

The victim was likely bending or kneeling under the forks outside of the safety sensor field to reach the plastic stringer. Because the LGV was not in emergency stop mode, the system reset when the obstacle was removed, bringing the elevated forks down, crushing him against the wheel cover of the vehicle.
